FAILURE STUDY IN SIDE PLATES OF A VIBRATING SIEVE

S. R. Allah Karam¹, M. Khodadad¹, M. Saadat Talab¹ and A.R. Moeini²

¹School of Metallurgy and Materials Engineering, University College of Engineering,
University of Tehran, P.O. Box: 11155-4563 Iran

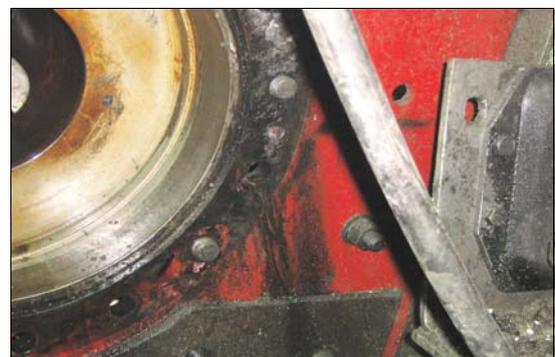
Fig. 2.: Failed plate of a vibrating sieve.

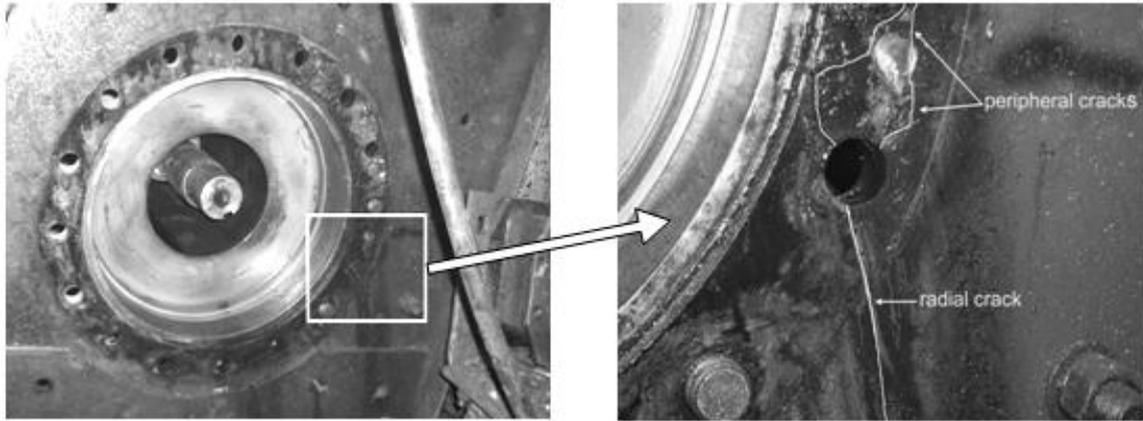
initiated from bolt holes and propagated in peripheral and radial directions with different lengths, as shown in Figure 3.

Fig. 3.: Peripheral and radial cracks in the side plate.

Visual inspection showed that there were severe damaged regions at bolt holes, and cracks initiated from these regions and propagated in peripheral and radial directions with different lengths. All cracks become through-thickness crack. There were some corrosion spots observed on the local bolt hole surfaces. The inner surfaces were rough and fretting wear scars could be observed on cracked surfaces, as shown in Figure 4.

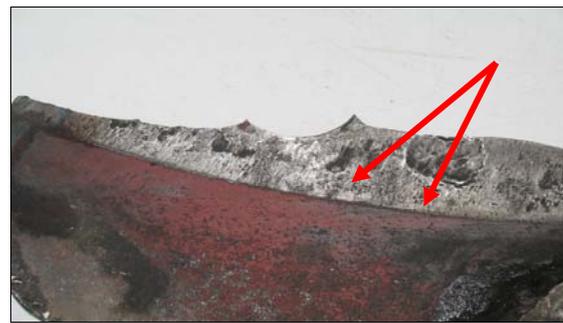
Fig. 4; The inner surface of bolt holes $\times 1$

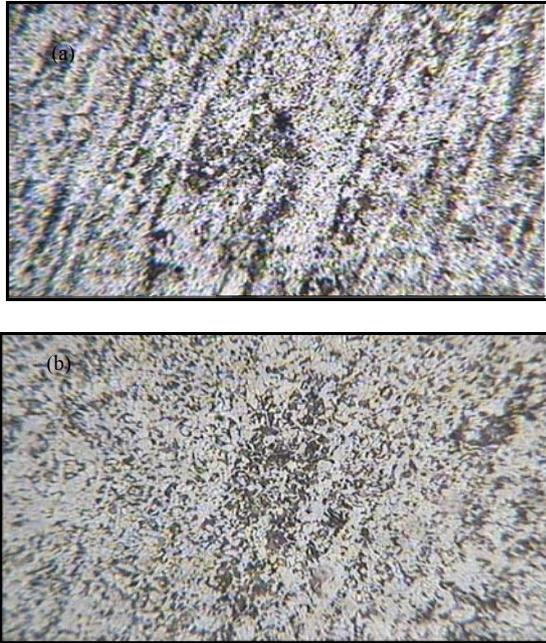
Light optical metallographic analysis was carried out on the failed plate. Samples for optical microscopy were prepared by grinding, polishing and then etched in 2% Nital. The microstructure is presented in Figures 5a and b. As it can be seen, the surface predominantly consists of lamellar ferrite and pearlit plates which are due to hot work done on the plate. Figure 6 shows the inner surface of the bolt hole, which seems to have severely suffered due to a rubbing mechanism between

Fig. 5.: a) Microstructure of failed plate $\times 50$, b) Microstructure of failed plate $\times 100$.

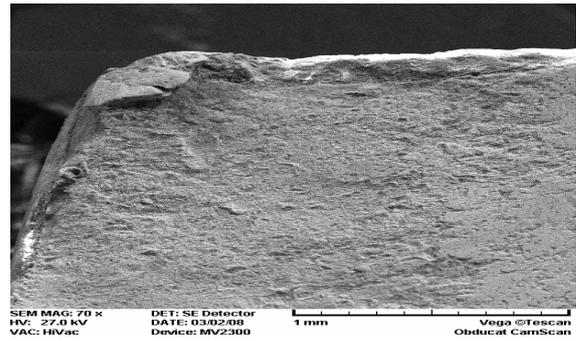
the bolt and the bolt hole surface, thus offering many available sites for crack initiation. The inner surface of the bolt hole which is indicative of the fretting damage zone provides many crack initiation sites. The X-ray diffraction analysis carried out on these sites indicated their chemical composition as iron oxides,

Fig. 6.: Inner surface of the bolt hole.

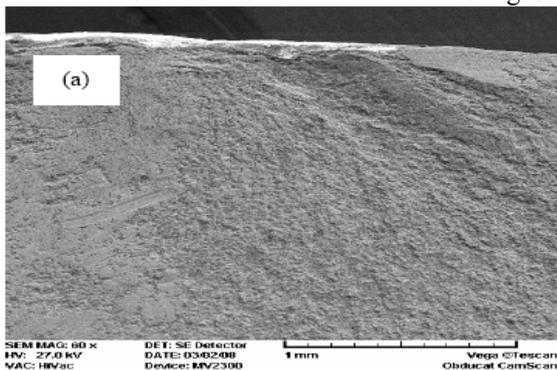
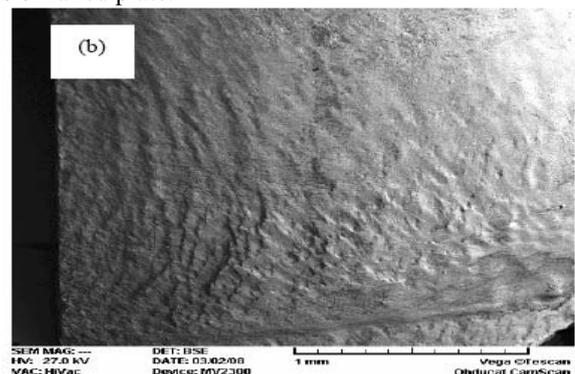
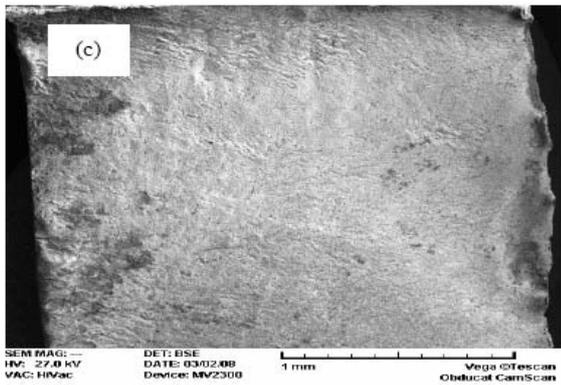
as shown in Figure 7. Figure 8 shows optical macrofracture appearance after separation. The fracture surfaces are roughened showing characteristic of fretting fatigue. Figure 8a shows details of the multiple cracks formed on fracture surfaces. Beach marks and radial lines can be observed in region 1 of the fracture surface. Figure 8b illustrates the fatigue beach marks in region 2. The brittle fracture mode can be clearly seen in the fracture surface as shown in Figure 8c. Many debris particles as an indication of wear were found on the bolt hole surface and at the mouth of cracks. Figure 9 shows the fracture surface of the bolt holes that contains a high amount of debris particles. The EDS analysis of debris particles represented in Figure 10 showed a high amount of oxygen, thus confirming oxidation of Fe during the service. (b) is responsible to form abrasive Fe_2O_3 particles in fracture surface.

Fig. 8.: Macrofracture appearance. a) details of the multiple cracks on fracture surface, beach marks and radial lines in region 1, b) fatigue beach marks in region 2, c) brittle fracture mode.

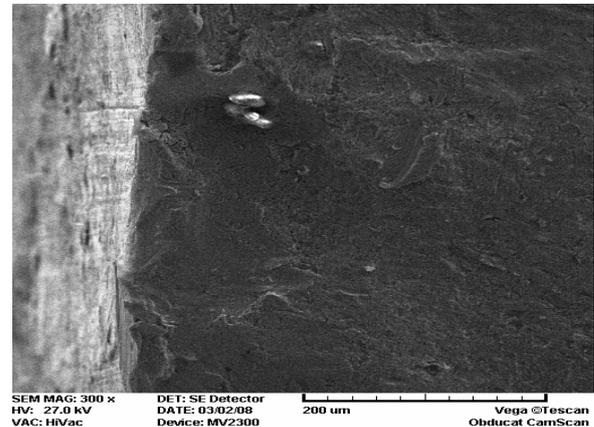
Scanning electron microscopic examination of the failed plate revealed roughness, microcracks, and pits in the surface-damaged regions. These are features of fretting damage. The cause of the fretting, in this case, was believed to be due to the self-loosening of the bolts. Fretting wear occurs from repeated shear stresses that are generated by friction during small amplitude oscillatory motion or sliding between two surfaces

Fig. 9.: fracture surface containing a high amount of debris particles.
