## THE INFLUENCE OF WELDING PARAMETERS AND CORROSIVE ENVIRONMENT ON THE JOINT STRENGTH OF RESISTANCE SPOT-WELDED MILD STEEL SHEETS

J. B. Shamsul, A. A. T. Ahmad Latiffi, K. R. Ahmad and Fazlul Bari

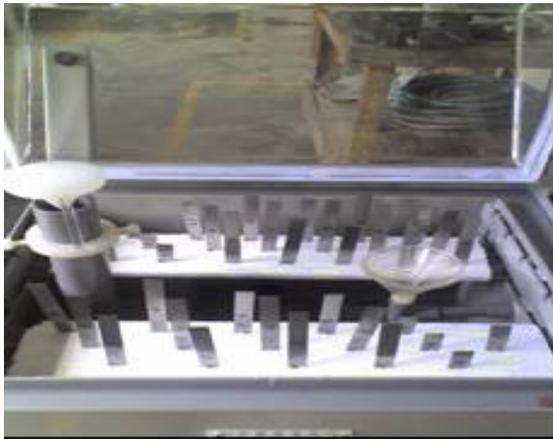
Fig. 2 Setting of specimens in salt spray machine

welded specimens were stuck on a polystyrene board so they will stand still to allow corrosion occur thoroughly (Figure 2). The test was carried out for 24 hours.

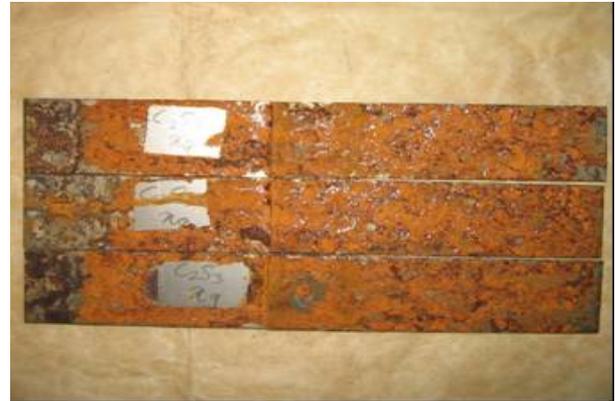
Fig. 4 Corroded specimens

The joints of spot weld according to the ANSI/AWS standard were sprayed with 5% sodium chloride for 24 hours. Result showed that the whole specimens have fully corroded (see Figure 4).

Observation of those corroded specimens explains the permeability of the mild steel to corrosion. The red colour rust was clearly appeared right after the specimens being removed from salt spray. Furthermore, the surface of the specimen shows some localized attack, some kind of intense dissolution on it.

Under image analyzer, it was hardly to see any pits or holes on the surface except the rust covering almost the whole surface. The occurrence of corrosion was also found at the lap joint. Almeida (Almeida, *et al.*, 1999) in her research reported that the study of a day cycle involving salt spray indicated more severe corrosion attack outside the lap joints than inside them.

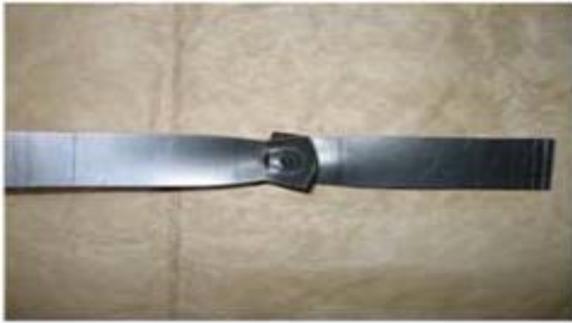
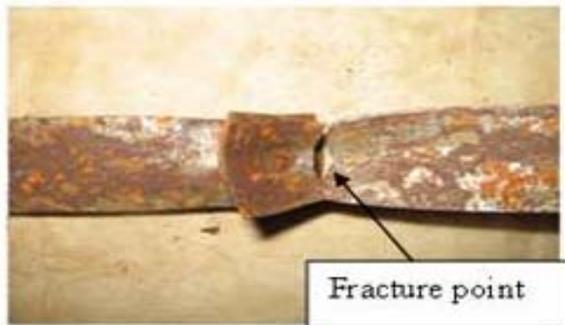
Fig. 5 Failed specimens after tensile-shear test: (a) Non-corroded specimen (b) Corroded specimen

An advanced chloride-rich wave in salt spray enhanced corrosion more extensively compared of being exposed in natural atmospheres, where successive wet and dry periods naturally occur, slowing the corrosion rate. Thus, a thick corrosion product layer, of which the main components are most probably ferric chloride accumulated from the upper panel outside the lap joint. During the tensile-shear test, the specimen elongates and the force of the load stress around the Heat-Affected Zone (HAZ) and finally, the specimen failed and deformed at a point called fracture point. The deformations involved elastic tension and bending of the specimen at the early stage and, then yielding and eventually fracture within the HAZ {see Figure 5 (a)}. The specimens from the non-corroded batch has formed fracture slightly at its HAZ area but the corroded batch seemed to be almost fractured and even the parent metal was tear off from the HAZ.
