SURFACE INTEGRITY OF AISI H13 TOOL STEEL IN END MILLING PROCESS

This paper presents the detailed investigation of surface integrity when end milling AISI H13 tool steels using P10 TiN coated carbide and P20 uncoated cermets tools. The machining parameters studied were cutting speed (224 m/min – 355 m/min), feed rate (0.1 mm/tooth – 0.25 mm/tooth) and depth of cut (0.3 mm-0.8 mm). The detailed microstructure analysis shows that worn out tools caused over heated of the machined surface and changed the microstructure of the work material. That change increased the hardness of the work material's machined surface, which is very hard and brittle, and generally referred as a white layer. The width formation of microstructure changes, increased with the increase in wear land and feed rate. A maximum of 550 HV was measured directly underneath the generated surface, i.e. 30% more as compared to the hardness of the basic material. This information is useful for the die and mould maker to select the best cutting condition to avoid such increase in hardness.

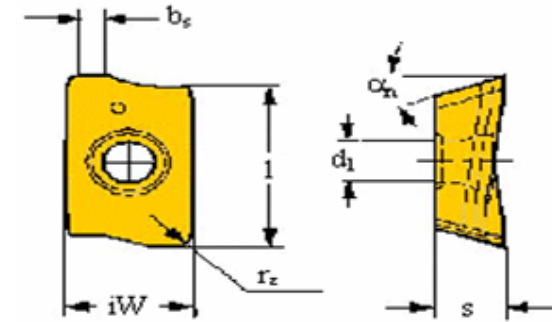
Figure 2 Insert shape and dimensions (Insert dimension: $l = 11$ mm, $iW = 6.8$ mm, $d_1 = 2.8$ mm, $s = 3.59$, $b_s = 1.2$ mm, $r_e = 0.8$ mm, $\alpha_n = 21^\circ$)

The machining trials were carried out on a Cincinnati Milacron Sabre 750 VMC in dry condition, as recommended by the tool supplier for the specific workmaterial. The insert used was flat end mill P10 TiN coated carbide and P20 uncoated cermets tools. In order to avoid the influence of tool run-out on wear measurements, only one edge of the insert was used for cutting whereas the other edge was ground flat. During the milling operation the insert was periodically removed from the tool holder, and the flank wear on the tool was measured accordingly. The length of each cutting path was set at 0.103 m. The tool wear on the flank face was measured after the first path. The measurement frequency of the tool wear required would then depend on the rate of the wear growth. The measured parameter to represent the progress of wear was the maximum tool wear VB_{max} . The detailed geometry of the two fluted end milling cutter assembly and detailed insert dimensions are shown in Figures 1 and 2 respectively

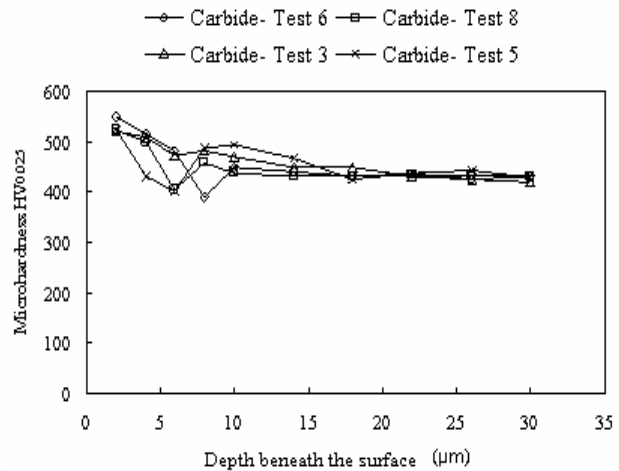
Figure 3: Microhardness variation when machining AISI H13 tool steel using worn out P10 tools

The microhardness measurements were taken using a Vickers indenter with a 25 gm load applied for 10 seconds. A hardness variation between the surface layer and the bulk material was measured. Figure 3 shows the microhardness variation when machining AISI H13 tool steel using worn out P10 tools. An analysis of result shows that the changes of microhardness did not occur beyond the depth of 30 μm . A maximum of 550 HV was measured directly underneath the generated surface as indicated in Figure 3 with abusive machining using Test 6 condition of the P10 tool. The increase in hardness was reaching up to 30% in relation to the hardness of the basic material. This changes in hardness is a heat-affected zone (HAZ), caused by thermal energy (Roger, 1971). Higher microhardness readings were obtained from the worn tools with uniform flank wear land (Test 6 and 8). The catastrophic failure with uneven form of fracturing and chipping on the Test 3 cutting edge caused a lower microhardness reading. This was due to the uneven contact between the worn edge and the workpiece surface. When this happened, the heat generated between the two mating surfaces was lower than that with the uniform wear land. The mating surfaces between the uniform wear land tool and the workpiece surface were fully intact as compared with the uneven wear land. Figure 4 shows the microhardness changes when using P20 tools for abusive machining with

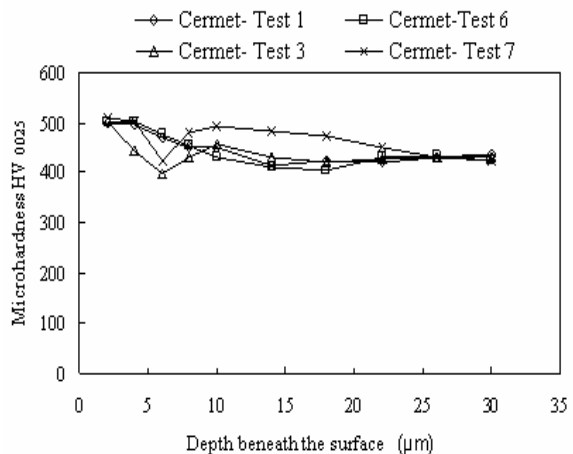
Figure 4: Microhardness variation when machining AISI H13 tool steel using worn out P20 tools

AISI H13 hardened steel. A maximum of 510 HV was measured underneath the machined surface. The increase of hardness was about 19% when compared with the basic material. The microhardness readings show similar values for all the selected test conditions due to the flank wear land was fixed at about 0.2 mm. However, one should note that 0.2 mm flank wear land was high enough to cause the subsurface microstructural alterations. Generally, both figures show a similar pattern. The microhardness values were at the highest values just beneath the machined surfaces. They started to decrease at certain length before increasing back and being constant when they reached the hardness of the basic material. The microhardness readings for P10 were found bigger than P20 due to the bigger sizes of flank wear land. The range of flank wear land for P10 tools was between 0.25 – 0.33 mm, whereas the flank wear land for P20 tools was fixed at about 0.2 mm.
