EXPERIMENTAL INVESTIGATION OF THE MICROSCOPIC DAMAGE DEVELOPMENT AT MODE I FATIGUE DELAMINATION TIPS IN CARBON/EPOXY LAMINATES

Abstract

Keywords: Delamination, Stress ratio effect, Fractography, micro-cracks

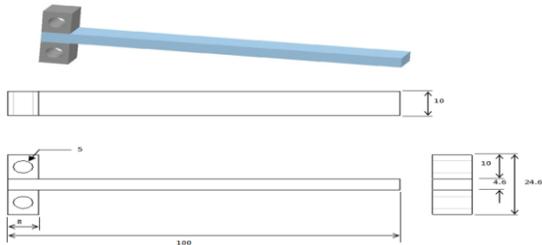
The geometry of the DCB test specimen used in this study is illustrated in Figure 1. The edges of the specimen were polished with diamond paste having sized grits equal to 0.6, 0.3 and 0.1 μm successively. After polishing, the edges were gold sputtered to avoid static charging during SEM. Aluminum blocks were bonded to the upper and lower sides of the specimens as shown in Figure 1. A hole was drilled in each block for the insertion of the pin.

Figure 1 Geometry of DCB specimen for in-situ SEM analysis [dimensions in mm]

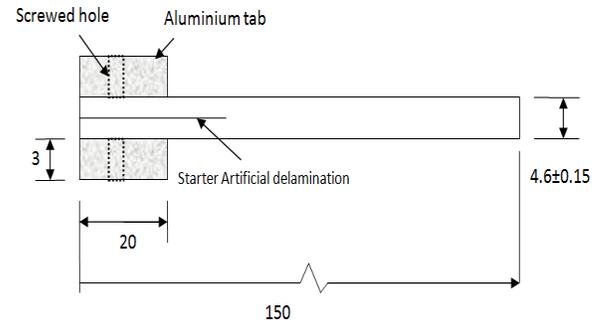
The DCB specimens were manufactured according to the same procedure as in previous section. The geometry of the specimen is shown in Figure 2. The specimen's width was equal to 10 mm. The width of current DCB was kept smaller than commonly used DCB specimen because it was tested/loaded by microtester installed inside SEM. The edges of the specimens were polished with diamond paste having sized grits equal to 0.6 and 0.1 μm successively.

Figure 2 Geometry of the specimen for the edge SEM after fatigue tests [dimensions in mm]

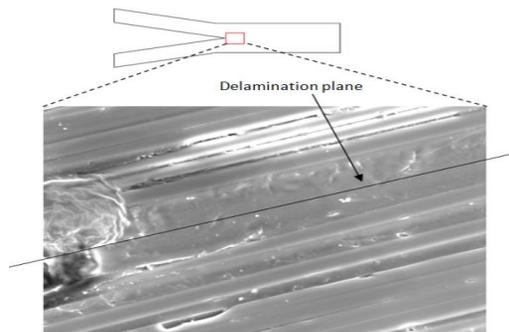
Figure 3 SEM image of the tip of the DCB specimen at 35 N, magnification X300 (Delamination growth direction from left to right)

As mentioned in section 2, the specimens were loaded by the micro-tester inside the microscope. During the test, the delamination tip was continuously monitored. It was difficult to capture high-quality images during the load application, because of high magnification microscopy and moment of the target location (delamination tip) due to deformation of the specimen. For this reason the loading was stopped after every load increment of 5 N, and a SEM image of the tip was then taken. The delamination started to grow at a load equal to 35 N. Seven SEM images were taken during loading. There was no obvious difference between the images taken before the delamination onset. Figure 3 shows a typical SEM image of the delamination tip at 35 N, just before delamination onset. Delamination growth direction is from left to right of the image. The matrix layer in the delamination plane can be seen as stretched at the right side of the image as compared to the left side as shown by red arrows in the image. No micro-cracking (cracks in the matrix layer between adjacent plies) was observed during loading up to 35 N.

The delamination growth was sudden as the load level crossed 35 N. Since the magnification of the SEM was high, the delamination tip was out of focus at that moment. The loading was stopped and it was observed that delamination had extended about 1 mm.

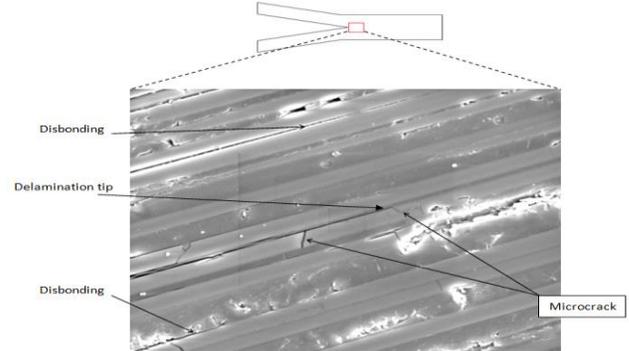
The SEM image of the delamination tip after the extension of 1 mm is shown in Figure 4. The figure shows two damage types in the vicinity of the delamination tip. These damage types are micro-cracks in the matrix layer and debonding of the fibres and matrix. It was observed in all cases that micro-cracks crossed the matrix layer touching both upper and lower fibres of the adjacent layers. The size (length) of the micro-cracks is not same. Figure 4 shows fully grown micro-cracks just before delamination growth where the intact matrix can be seen as ligament bridging the delamination plane plies. The formation of hackles is

often attributed to the coalescence of micro-cracks [12, 18]. In that case it would be expected that delamination locally jumps from one plane to another. The damage mechanisms are not confined only to the delamination plane.

Figure 4 Matrix ligament bridging at the delamination tip (X300), In-situ 1, (Delamination growth direction from left to right)

What is deemed of interest here is that there seems to be more than just a single delamination plane when observed at a microscopic level. For example, Figure 4 illustrates that multiple parallel cracks are being formed of which the lead delamination in its plane remains the dominant one. This implies that studies reporting the delamination fracture surfaces using microscopy do not reveal the fact that subsurface other delamination fractures may be present. In particular studies that attempt to relate the strain energy dissipation to the formation of fractures [21, 22], should consider that the fracture features observed with microscopy fail to reveal these subsurface fractures.

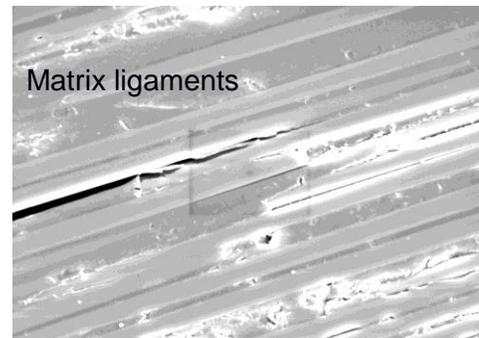
Debonding between plies in a range of 2-3 plies was observed in the upper and lower plies of the delamination plane as shown in Figure 5.

Figure 5 SEM image of the tip of the DCB specimen after delamination growth, In-situ 1, magnification X300 (Delamination growth direction from left to right)

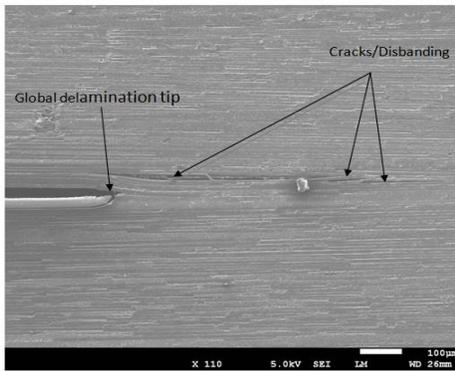
This section presents the results of the SEM investigations on the edges of the DCB specimens that were tested under fatigue. Figure 6 shows a typical SEM image of the delamination tip of a specimen. The existence of cracks/disbanding ahead of the delamination tip can be seen in the image. The size of these cracks decreases as the distance from the tip is increased. These cracks are not in one plane (i.e. in-line with main delamination), instead they are alternatively changing position above and below the delamination plane. The coalescence of these cracks/disbanding results in the delamination extension. However, in that case the delamination locally jumps in its path around the global delamination plane.

Figure 6 SEM image of the delamination tip, Specimen SEM 3 ($G_{max}=79.6 \text{ J/m}^2$), magnification X110 (Delamination growth direction from left to right)

The local shift in the delamination plane involves several fibres above and below the plane that later on result in bridging fibres as shown in the figure. A clearer SEM image showing bridging fibres in the delamination wake behind the tip is shown in Figure 7.

In the current study, it is observed that the macroscopic delamination tip is preceded by micro-crack formation in the matrix approximately in the plane of the delamination. At the microscopic level, these micro-cracks were observed to be not exactly positioned at the plane ahead of the lead-delamination tip, but at varying distances from that plane. In all observed cases however, the cracks propagated parallel to the direction of the lead-delamination. Depending on the misalignment of these micro-cracks, the formation of two different features was observed. In most cases, microscopically small misalignments led to the formation of hackles in the matrix at the moment these micro-cracks coalesce. Occasionally, the misalignment covered a distance including some fibres bundles, leading to the formation of bridging fibres, as illustrated by the Figures 6 and 7.

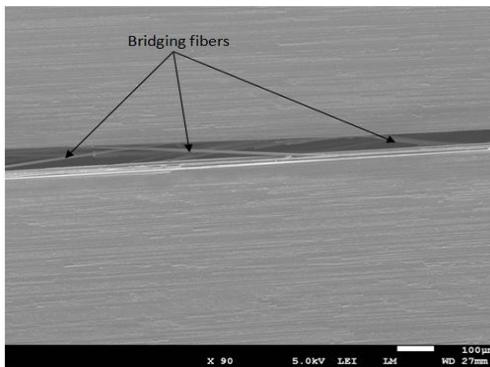
Figure 7 Bridging fibres in delamination wake, SEM 3, X90 (Delamination growth direction from left to right)

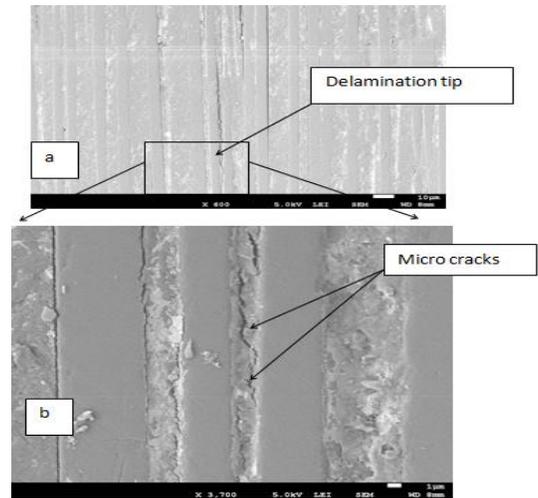
Figure 8a shows micro-cracks in the matrix layer between adjacent plies in the specimen *In situ* 4. Three delamination fronts/ disbanding can be seen in the figure, acknowledging alternation of local delamination plane as discussed in the previous paragraph. Figure 8b is the magnified view showing details of the micro-cracks ahead of delamination tip. It can be seen that the micro-cracks are approximately parallel to the fibres of the adjacent plies and also parallel to the delamination growth direction, however some micro-cracks are slightly oriented to the adjacent ply.

Figure 8 SEM images of the delamination tip, Specimen SEM 4 ($G_{max}=81 \text{ J/m}^2$), (a) magnification X600 (b) magnification X2300, (Delamination growth direction from top to bottom)

The density/number of micro-cracks may depend on many factors like the number of fatigue cycles, the level of loading and the local thickness of matrix between adjacent fibres. Figure 9 illustrates SEM image of the delamination tip in the specimen SEM 5. The density of the micro-cracks in this figure is much higher as compared to Figure 8.

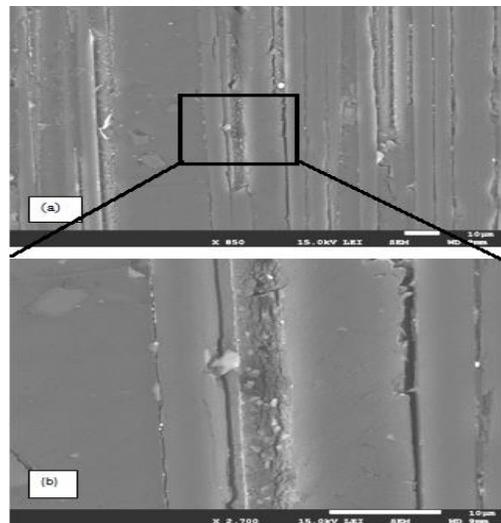
Figure 9 SEM images of the delamination tip, Specimen SEM 5 ($G_{max}=84.4 \text{ J/m}^2$), (a) magnification X850 (b) magnification X2700 (Delamination growth direction from top to bottom)
