DAMAGE ASSESSMENT BASED ON MODAL ANALYSIS OF PIPE STRUCTURE

Sakhiah Abdul Kudus*, Yasuo Suzuki, Masahide Matsumura, Kunitomo Sugiura

Department of Civil and Earth Resources Engineering, Graduate School of Engineering, Kyoto University, Kyoto, 616-8540, Japan

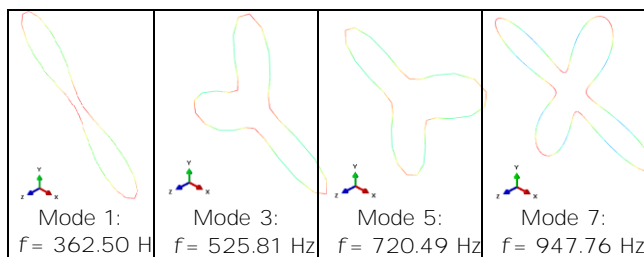
Figure 3 Circular cross section of steel pipe during vibration

Figure 3 represents the circular cross section of the steel pipe during the vibration for mode 1, mode 3, mode 5 and mode 7. In the breathing mode, the pipe extends radially around its circumference. There are two lobe shapes in mode 1, three lobe shapes in mode 3 and mode 5, and four lobe shapes in mode 7, as per the results of the cross section figure. Mode 3 and mode 7 have the same vibration pattern, but mode 7 showed two independent regions of vibration in the axial direction. Mode 7 has a higher independent region of vibration compared to mode 3.

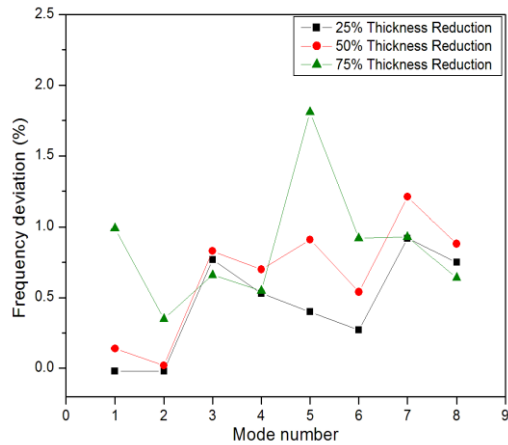
Figure 4 Deviation of natural frequency in the first eight mode of steel pipe tube for damage case 1 of 2% designated area

The change in natural frequency is one of the indicators of the existence of damage in the structure. With 2% of designated damage area in the pipe model, the reduction in natural frequency can be observed. Figure 4 presents the graph of frequency change in the 2% size of damage case 1. In damage case 1, the damage was located in the middle part of the pipe. The higher deviation of natural frequency was observed in mode 5 with 75% of thickness reduction. Overall, the deviation of natural frequency was small around 1% for a three levels of cut off depth.

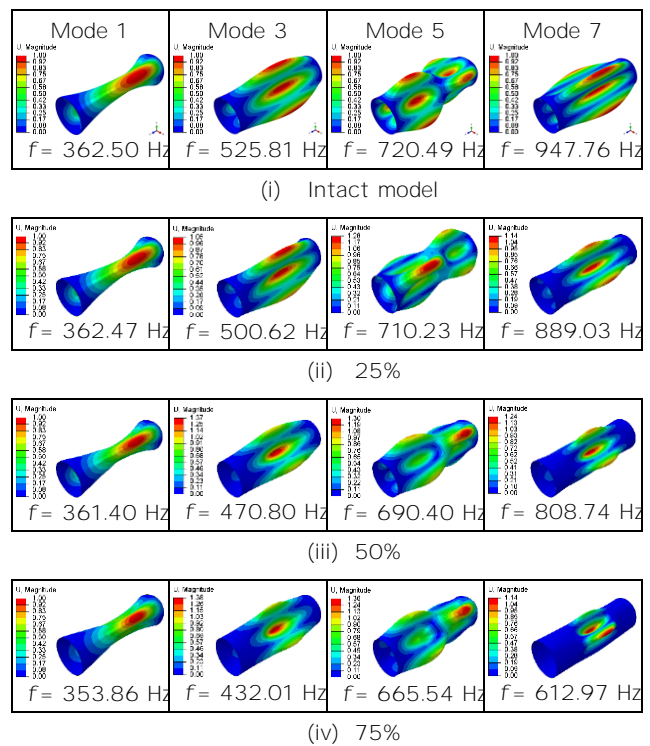
Figure 7 Pattern switch in mode shape due to 10% designated area of damage case 1 in steel pipe

Additional assessment based on mode shape results was conducted as shown in Figure 7. The large switch in mode shape has been expected to occur around the damaged region, which is invaluable for the prediction of the location of damage in the structure for further investigation. At first, when small damage of 25% of thickness reduction was introduced to the pipe model, there was no distinct change between the damaged model and reference model. With an increase in the level cut off depth to half of the thickness, there was clear localisation in local mode 7. Mode 7 represents the more localised mode of vibration among others modes which possessed a higher number of independent vibrations in the region. The mode shape localisation in this particular mode due to damage was more apparent compared to mode 1, mode 3 and mode 5. Further, as the level cut off depth increased to 75% thickness reduction, more localisation occurred in local mode 7. There was almost zero vibration in surrounding damaged regions, and the vibration was dominant only in the damaged region.

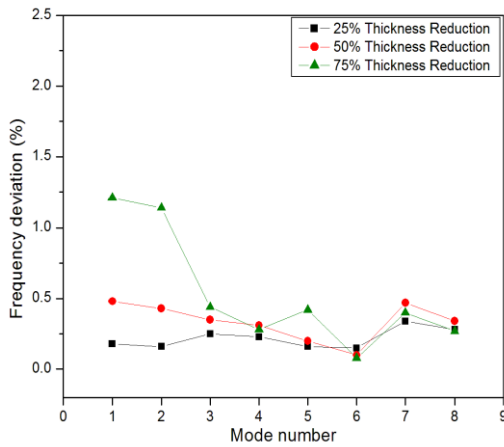
Figure 8 Deviation of natural frequency in the first eight mode of steel pipe tube for damage case 2 of 2% designated area

In damage case 2, the position of damage was switched to the quarter end of the pipe. A clear pattern switch of frequency deviation cannot be obtained when only small damage was introduced to the system as 2% of damage in damage case 2. This is illustrated in the graph of frequency deviation in Figure 8. It was supposed that with increases in damage severity, there would be an increase in the reduction of natural frequency. In this case, the highest frequency deviation occurred in mode 1 for 75% of thickness reduction with a value of 1.41%. The average value of frequency deviation was around 0.5% and below.

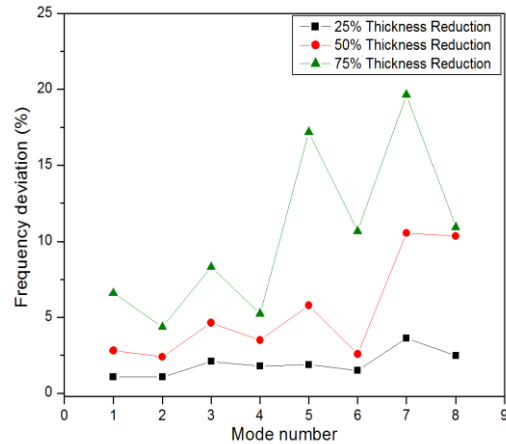
Figure 10 Deviation of natural frequency in the first eight mode of steel pipe tube for damage case 2 of 10% designated area

In this stage, the damage size increased from 2% to 10% to study the effect of the size of damage in case 2. Figure 10 displays the results of frequency change in three level cuts of depth. In large damage case simulations, it was clear that increased levels of damage increased the frequency deviation. Mode 7 and mode 5 show the higher sensitivity based on the higher deviation of frequency.

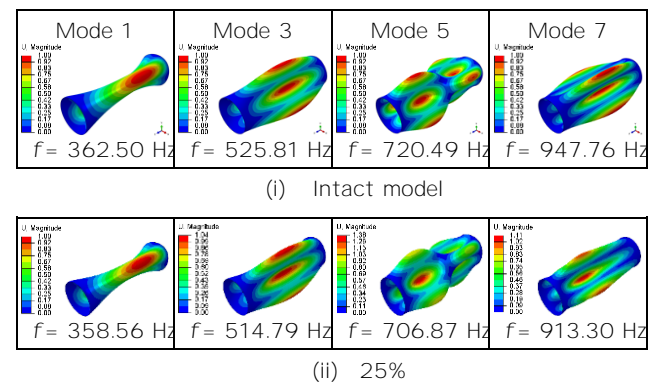
(ii) 25%

Figure 11 Pattern switch in mode shape due to 10% designated area of damage case 2 in steel pipe

Figure 11 shows the mode shape deviation with the introduction of 10% damage in case 2. Mode 7 shows large deviation in 25% of thickness reduction. Further, with the increase of another 25% of thickness reduction, the vibration started to dominate the damaged region. At the last stage, in 75% of thickness reduction, the mode was localised only in the damaged region with zero displacement surrounding the designated damaged region.

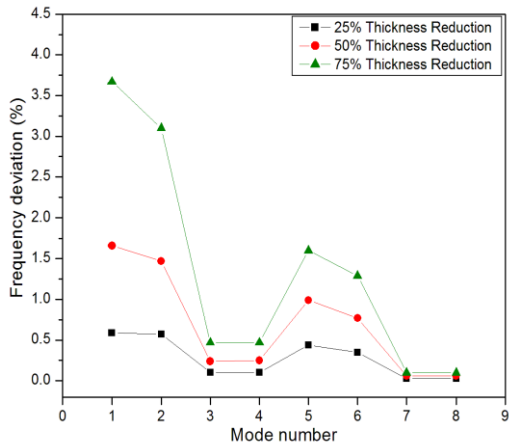
Figure 12 Deviation of natural frequency in the first eight mode of steel pipe tube for damage case 3 of 2% designated area

The damage was located at the end of the pipe in damage case 3. The effect of the position, size and level cut of depth towards the modal parameter was further assessed in this damage case simulation. Figure 12 shows the deviation of natural frequency for small size of damage case 3. With the increase in thickness reduction, the frequency deviation also increased. Couple mode 1 and mode 2 shows higher deviation in natural frequency compared to others modes followed by couple mode 5 and mode 6. Couple mode 7 and mode 8 shows less frequency deviation indicating that this mode is less sensitive to the presence of damage case 3.

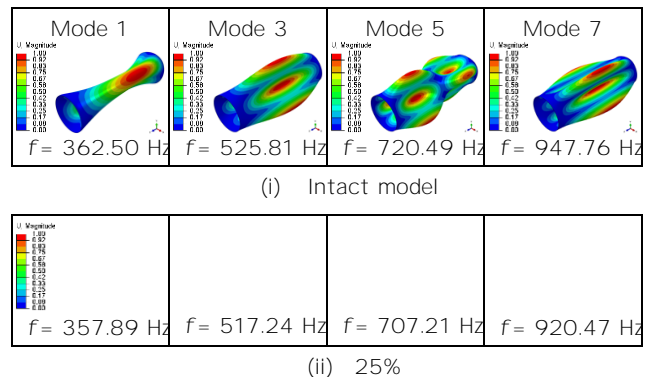
Figure 14 Deviation of natural frequency in the first eight mode of steel pipe tube for damage case 3 of 10% designated area

The pattern of frequency change was not the same between small damage and large damage sizes. Figure 14 shows the deviation in natural frequency when the damage areas increased to 10%. In this case, mode 7 followed by mode 5 show higher deviations in frequency which is different from the lowest state of damage observed in Figure 12. In 25% of thickness reduction, the frequency deviation between each mode extracted was minimal.
